Super Salvage, Inc.
Industrial Stormwater Inspection Report

Appendix B

Photograph Log and Photographs

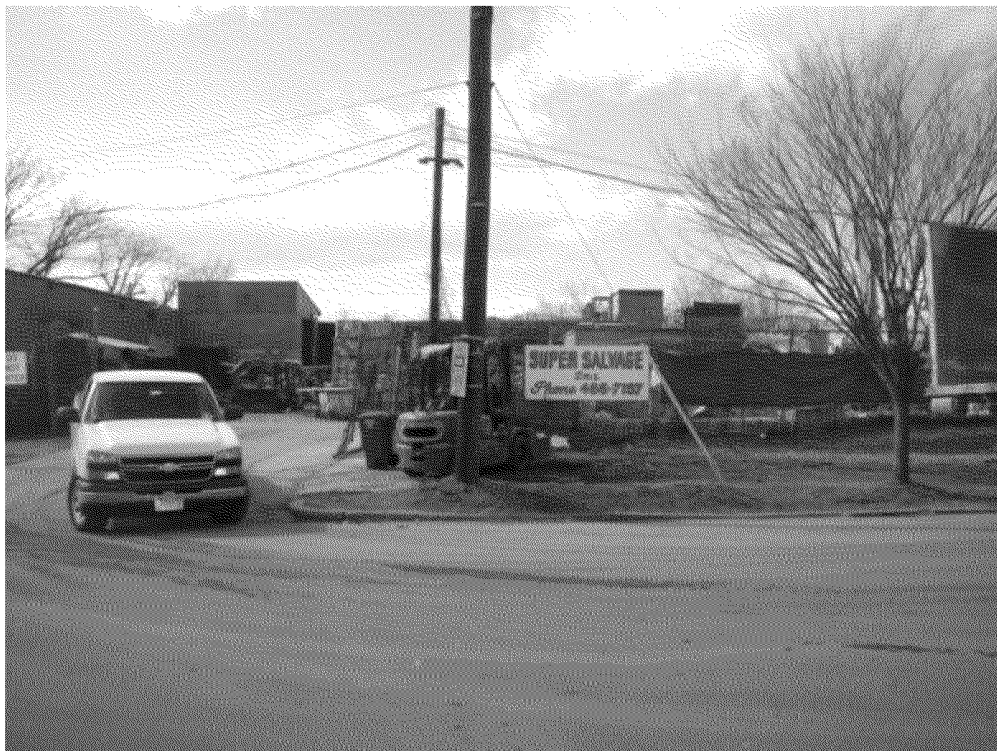
Photograph 1. Facility sign and vehicle track out at Entrance 1.

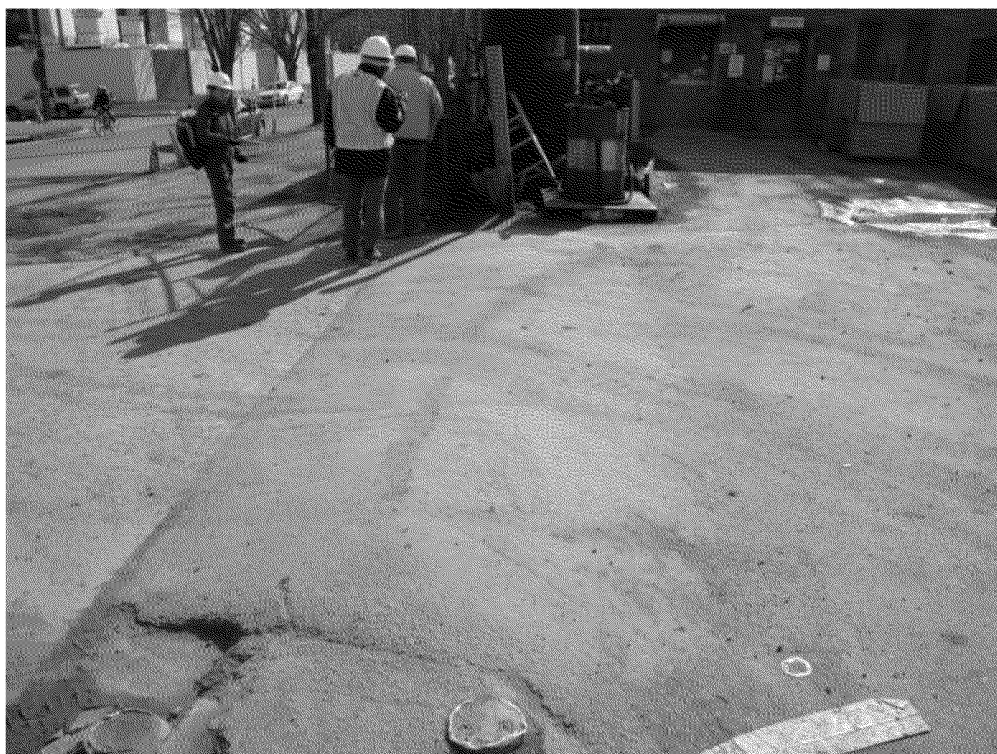
Photograph 2. Berm at Entrance 1 of the site.

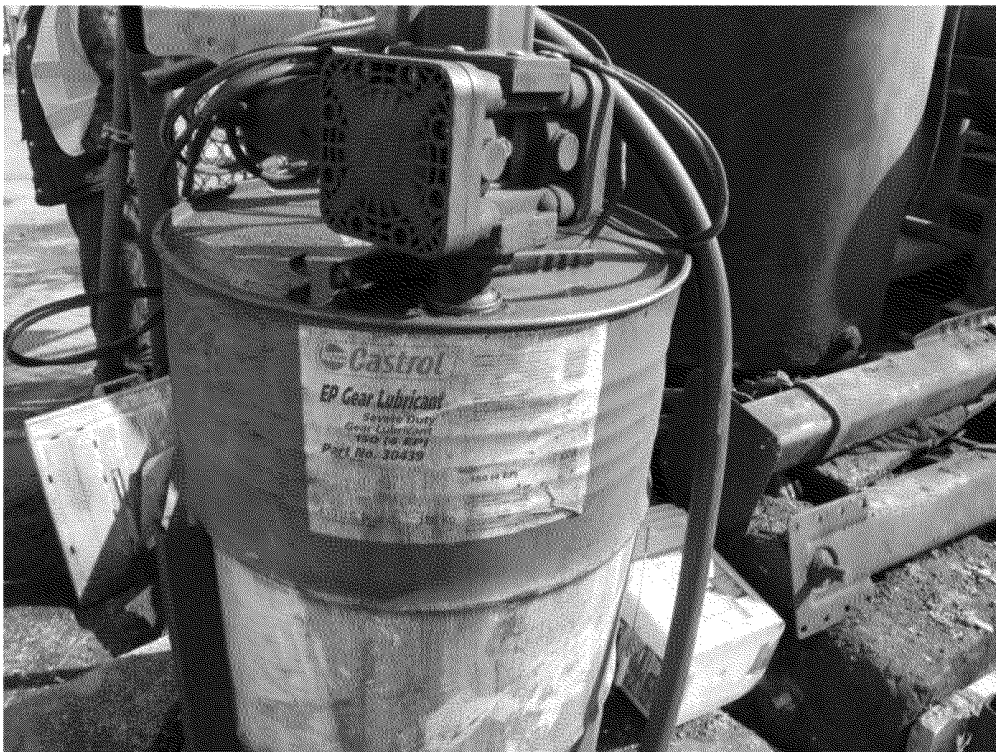
Photograph 4. **Close up view of the lubricant label on the barrel in Photograph 3.**

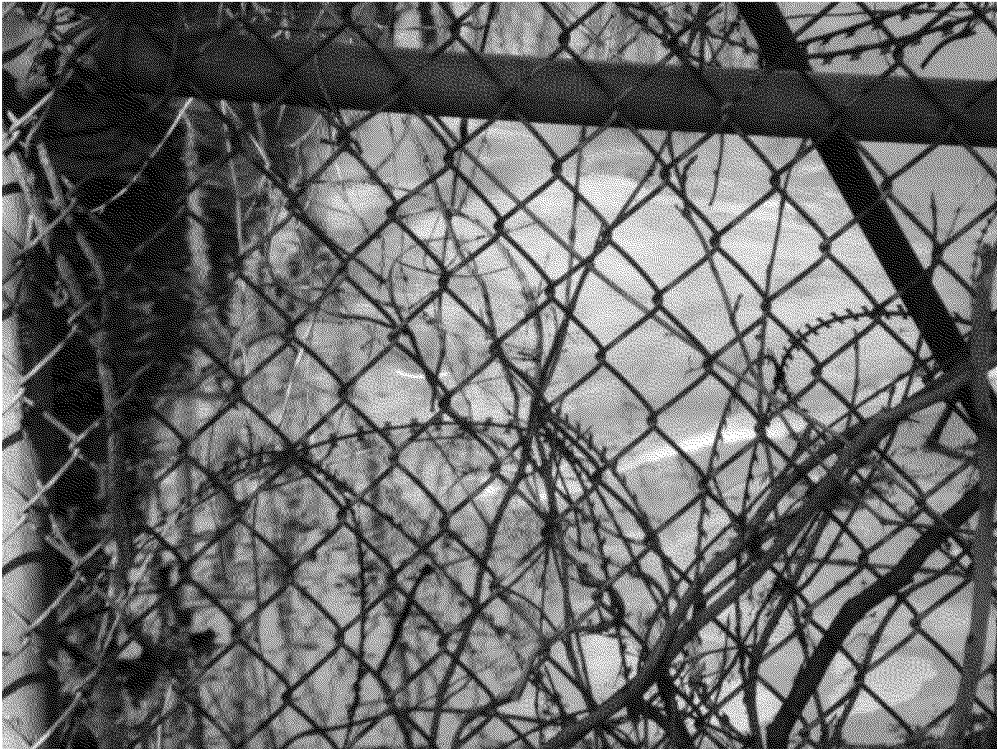
Photograph 7. Close up view of the sheen on the large runoff collection pond.

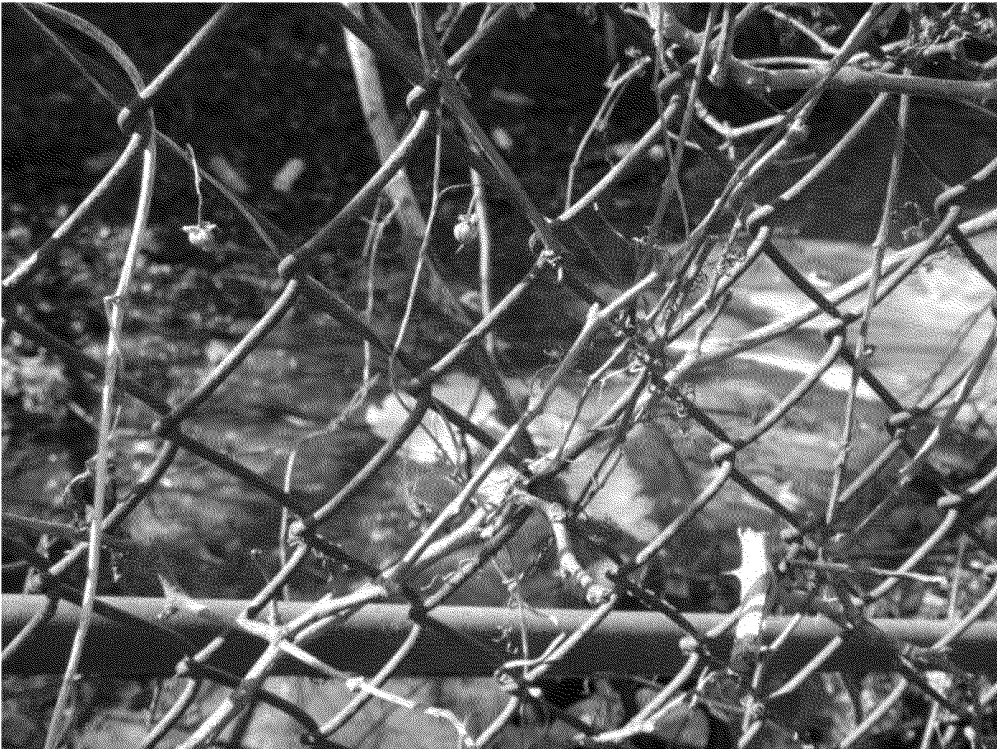
Photograph 8. Alternate view of the sheen on the large runoff collection pond.

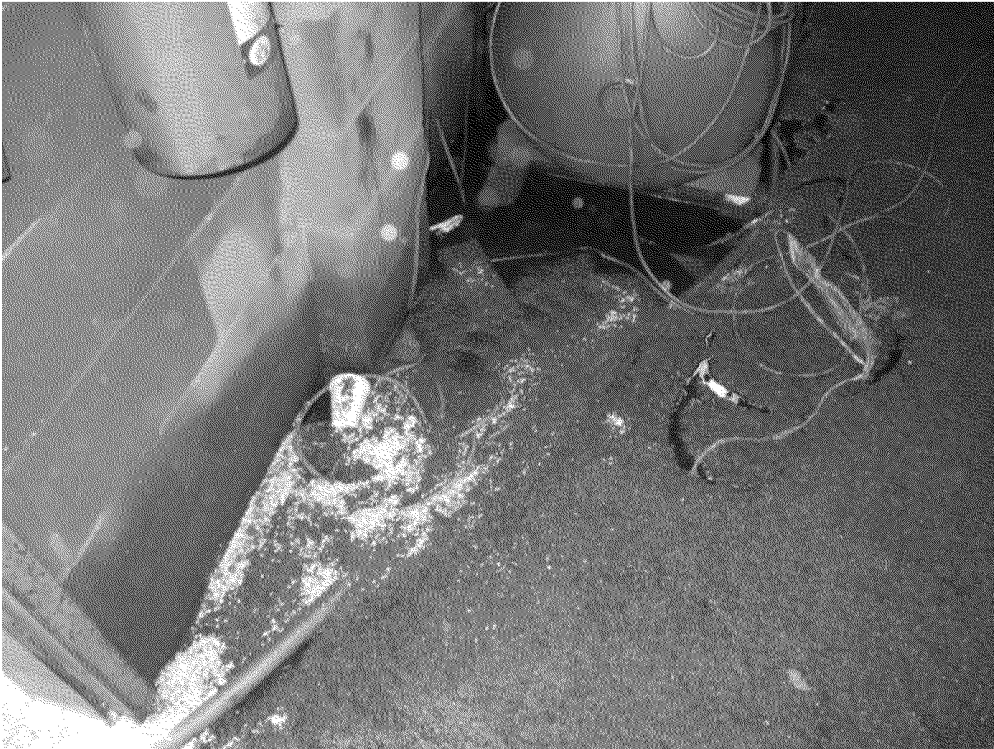
Photograph 21. Alternate view of Photograph 20.

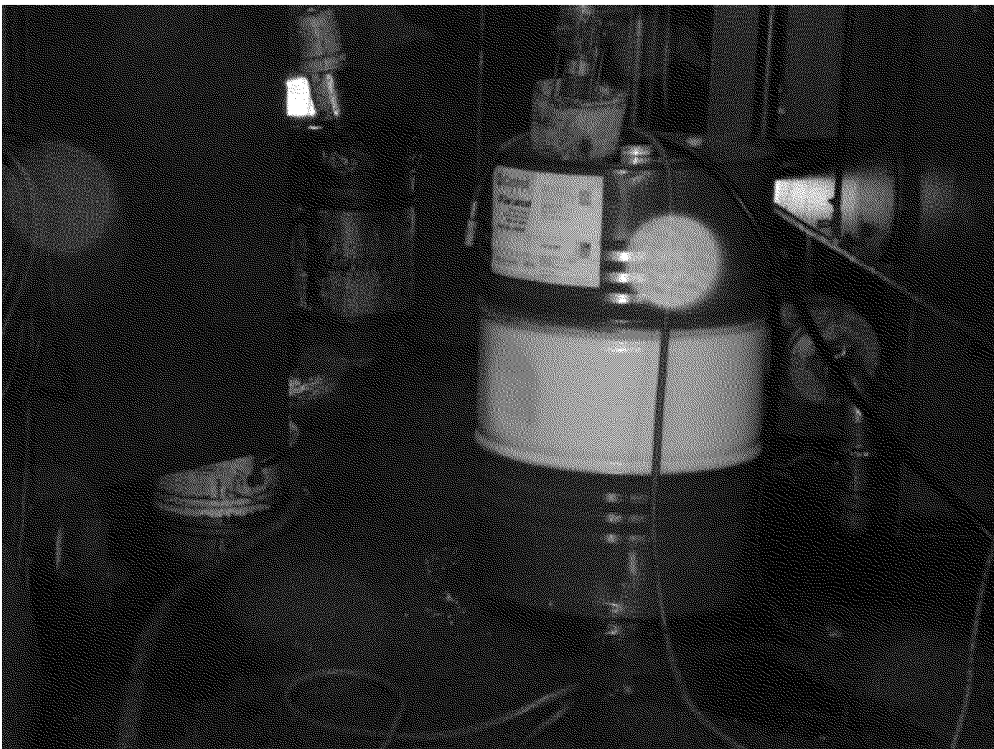
Photograph 22. Close-up of two tanks in the building leaking onto the floor.

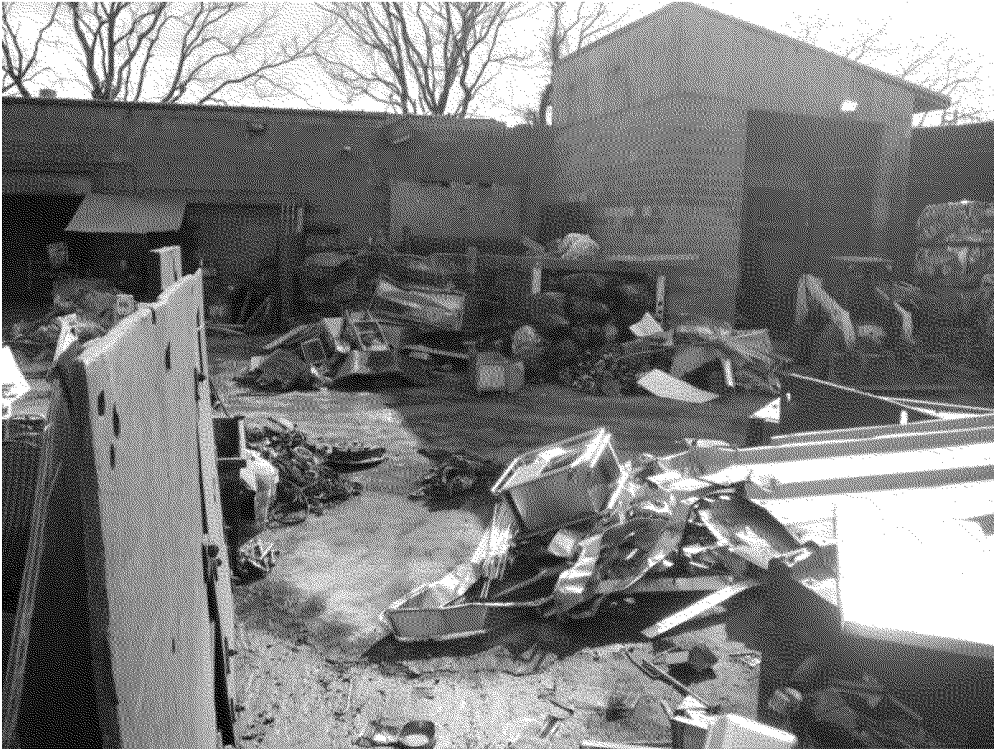
Photograph 27. Overall view of the facility from the roof of the scrap bay.

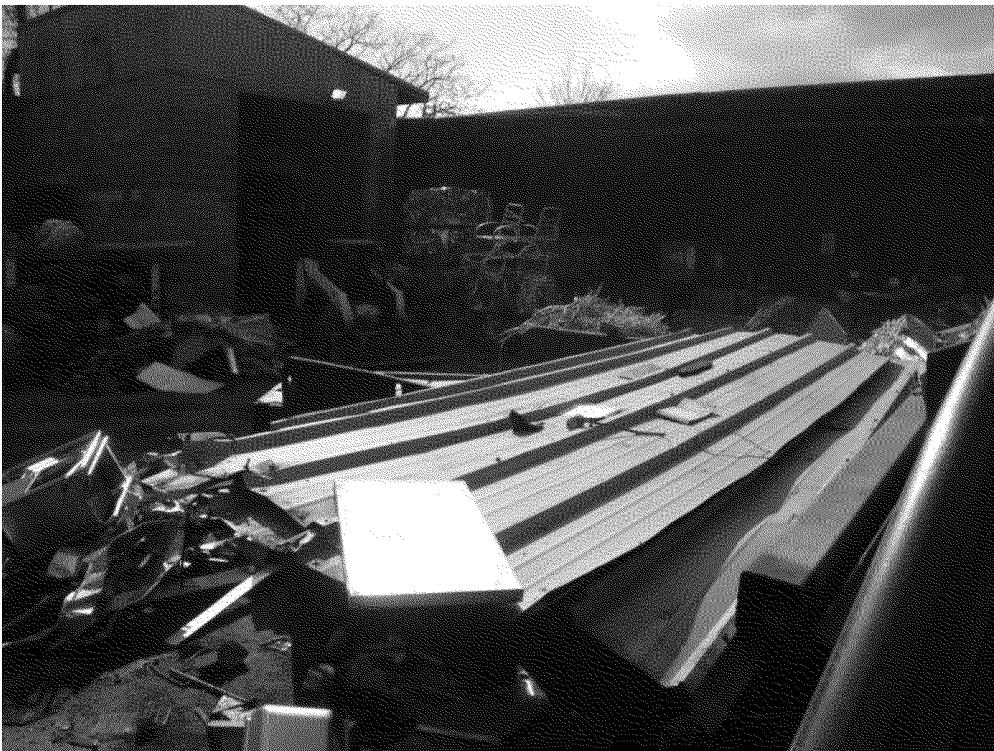
Photograph 28. Another overall view of the facility.

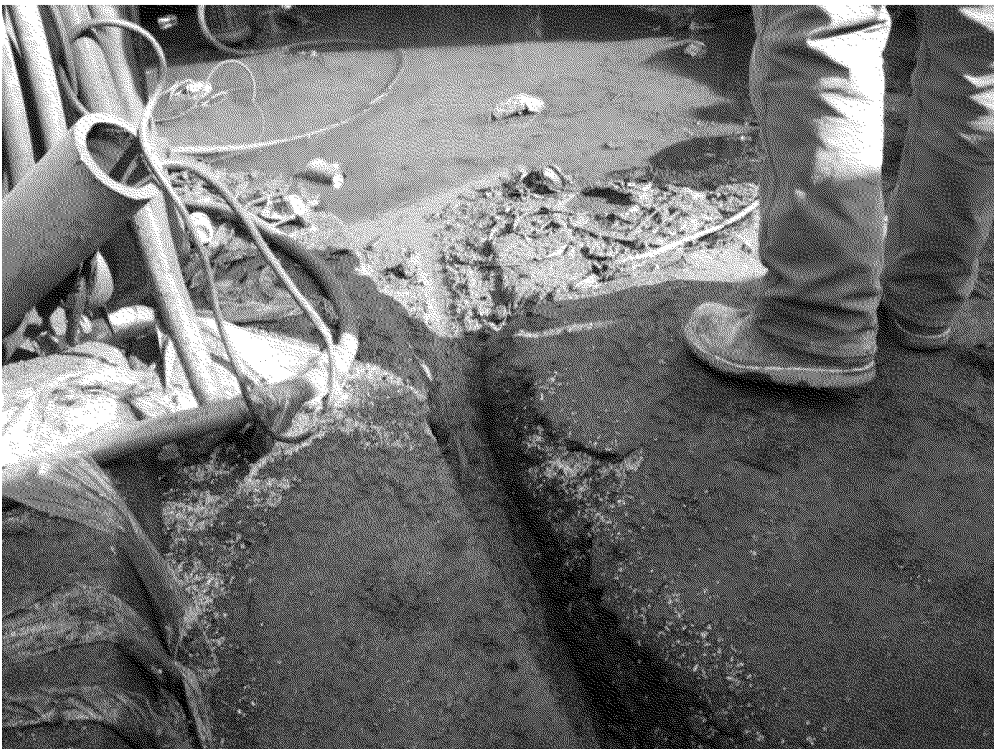
Photograph 30. The end of the trench leading into the small runoff collection pond.

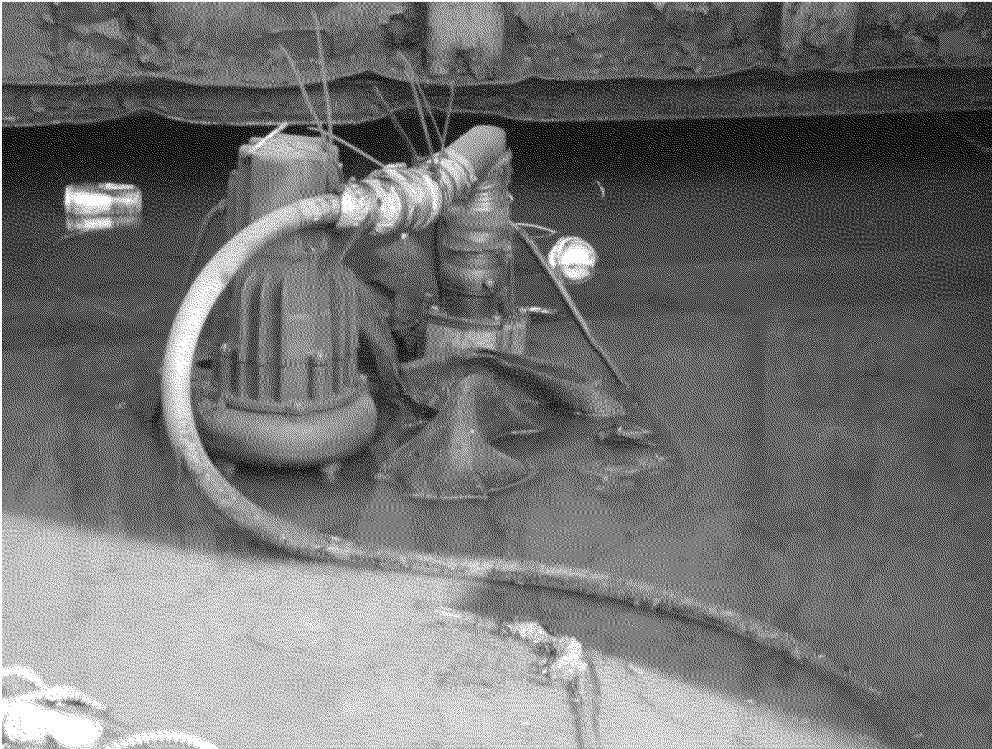
Photograph 31. Close-up view of the manual pump in the small runoff collection pond.

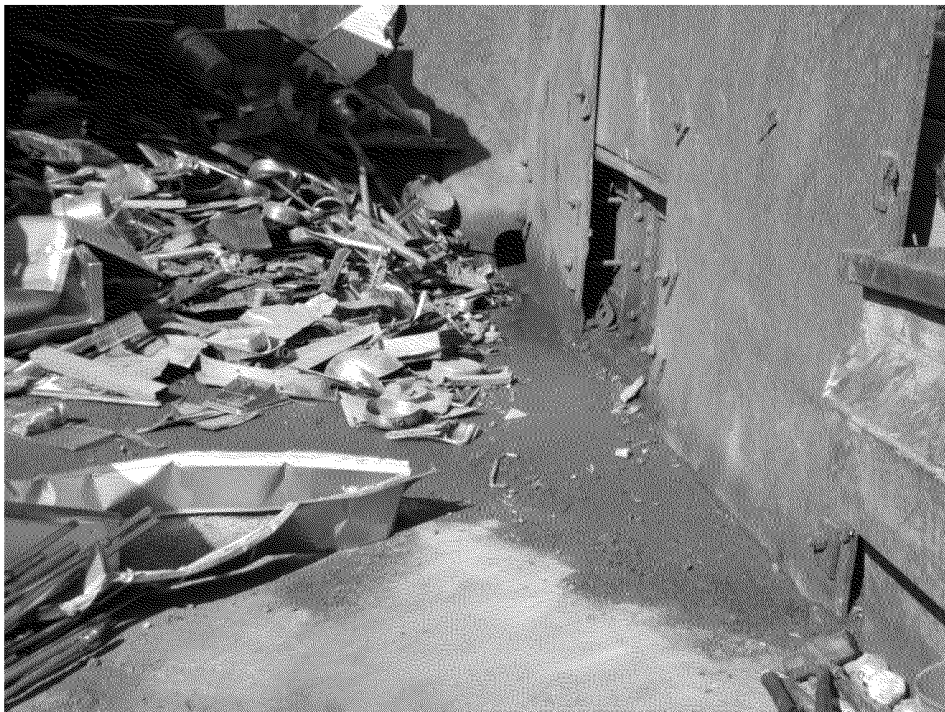
Photograph 32. Alternate view of the entrance to the trench from the opposite side of the wall shown in Photograph 30.

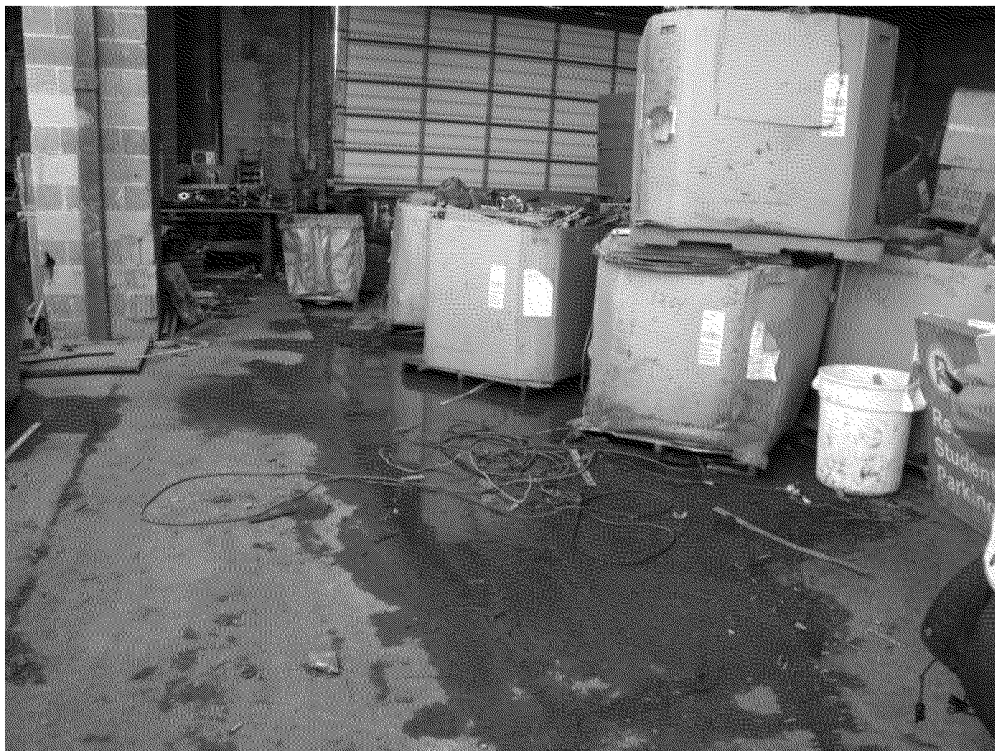
Photograph 33. Heavy staining on the concrete floors.

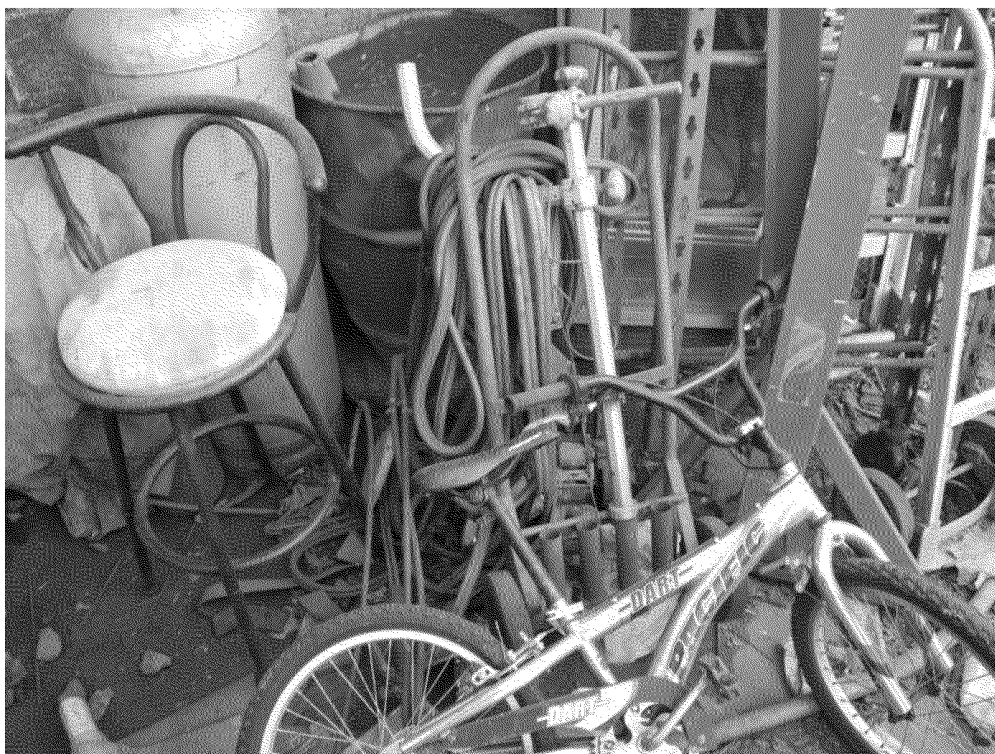
Photograph 34. Debris adjacent to the large runoff collection pond.

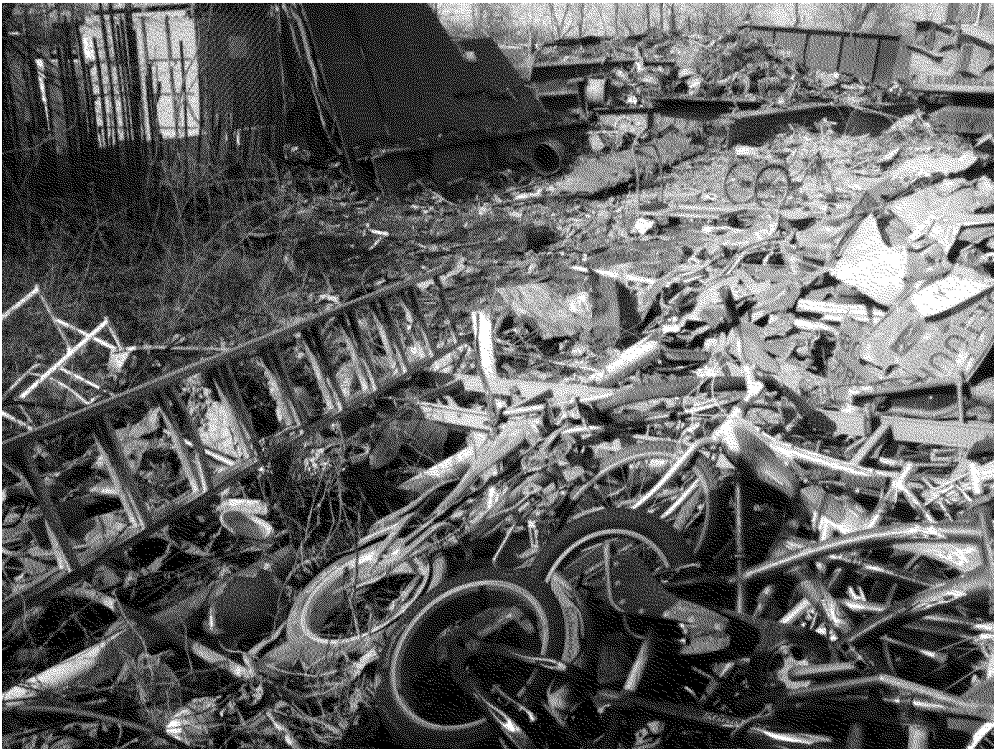
Photograph 36. View of debris just right of the large runoff collection pond.

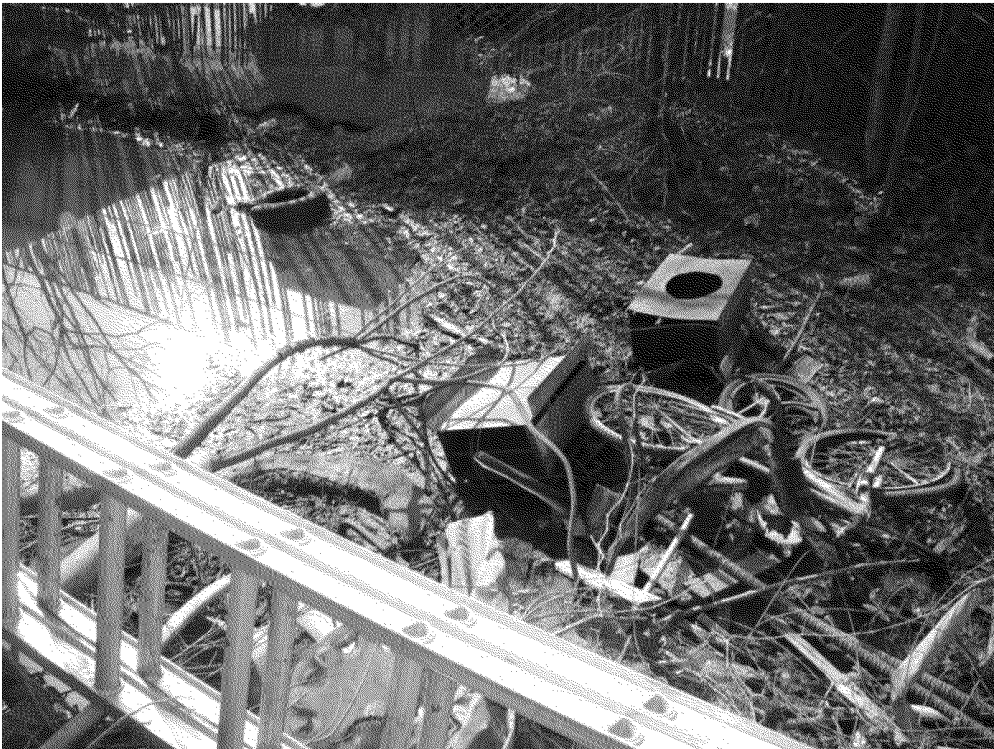
Photograph 38. Ladder next to the northern end of the large runoff collection pond.

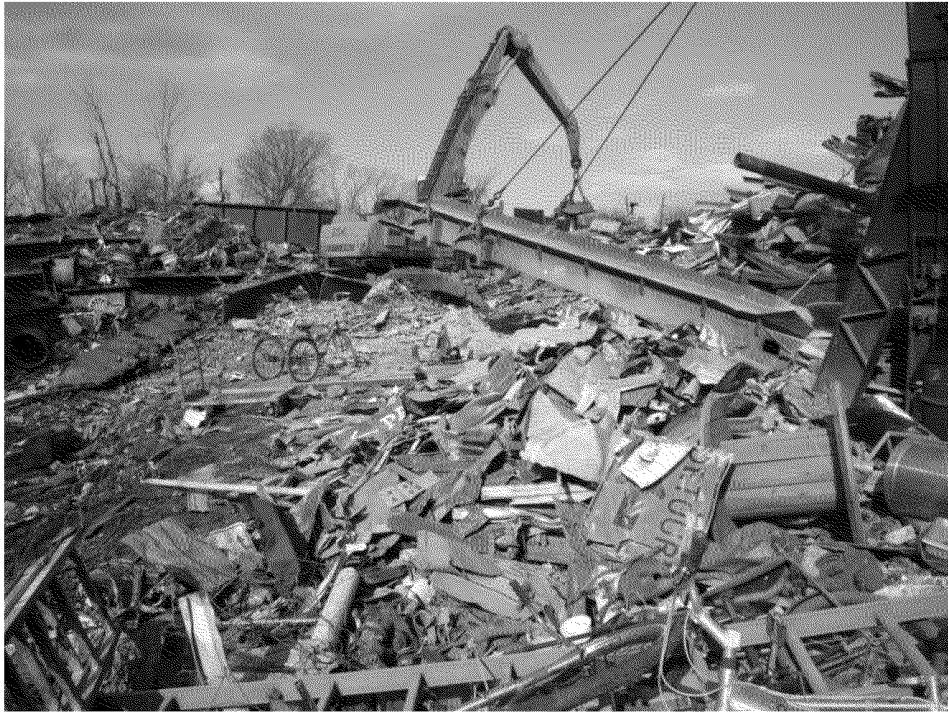
Photograph 41. Overall view of the facility from the northern end of the large runoff collection pond.

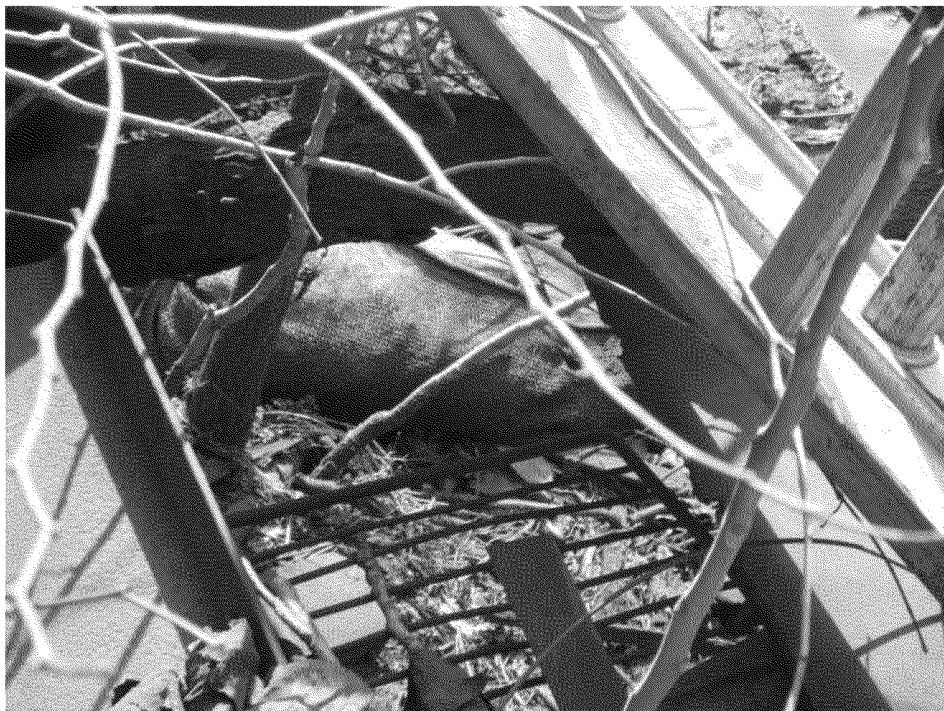
Photograph 43. Close-up view of the absorbent sock with orange indicating its original color at the northern end of the large runoff collection pond.

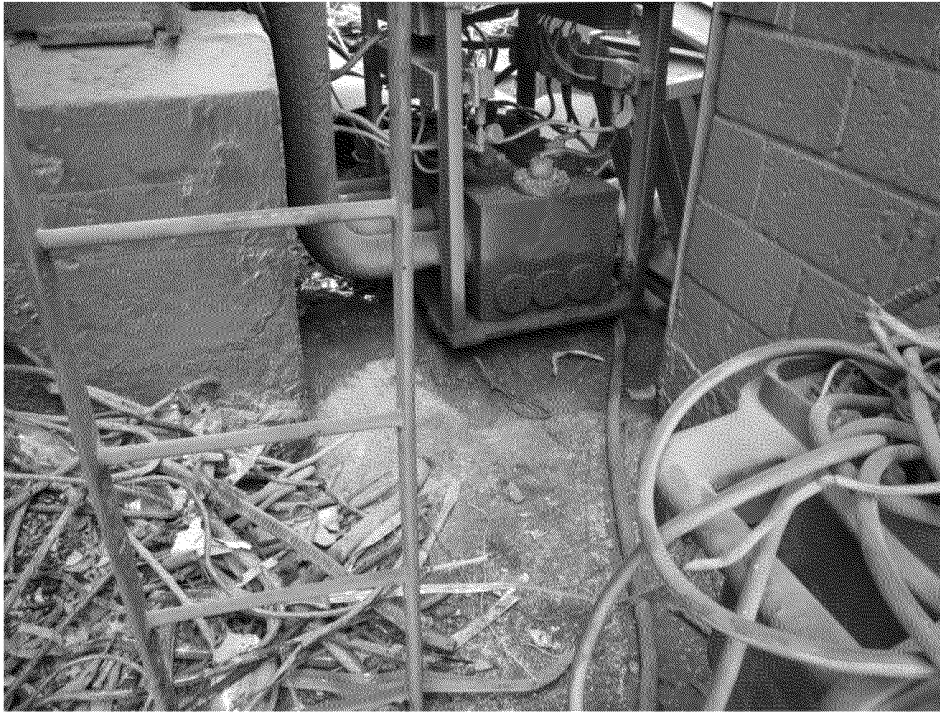
Photograph 45. Fluid leaking from under the conveyor belt of the “crusher”.

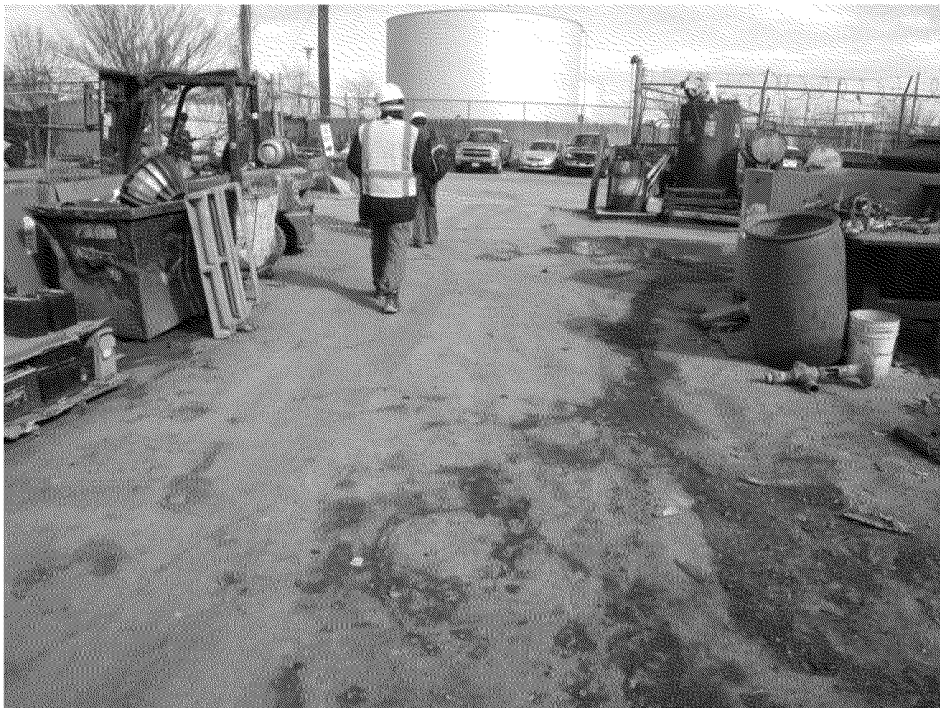
Photograph 46. View of Entrance 1 from the inside the yard showing staining on the ground.

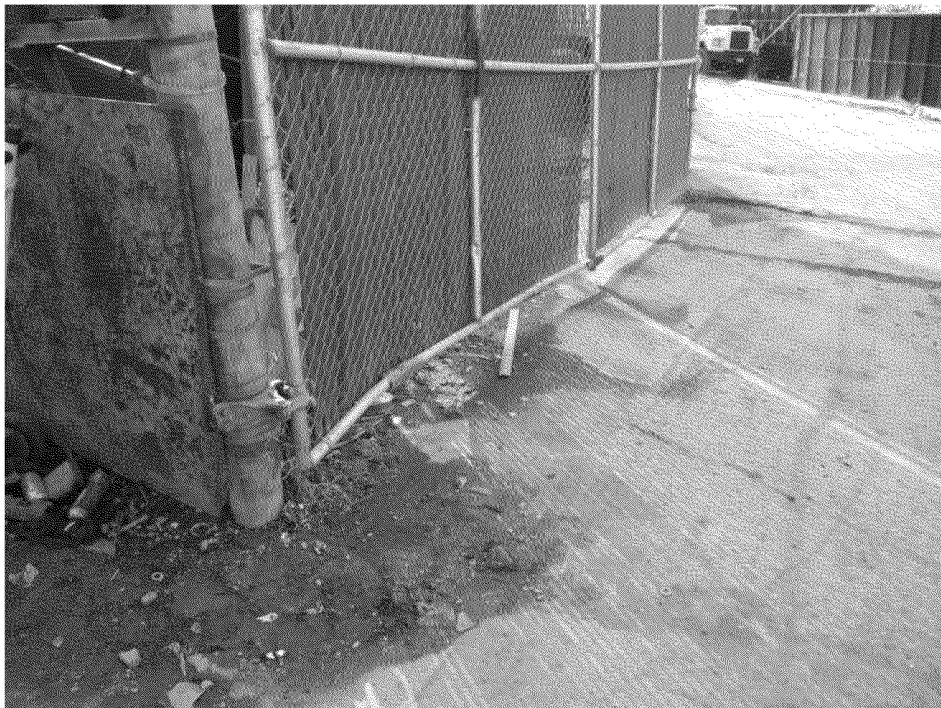
Photograph 56. Staining passing under the property fence onto the District of Columbia (DC) property near Entrance 2.

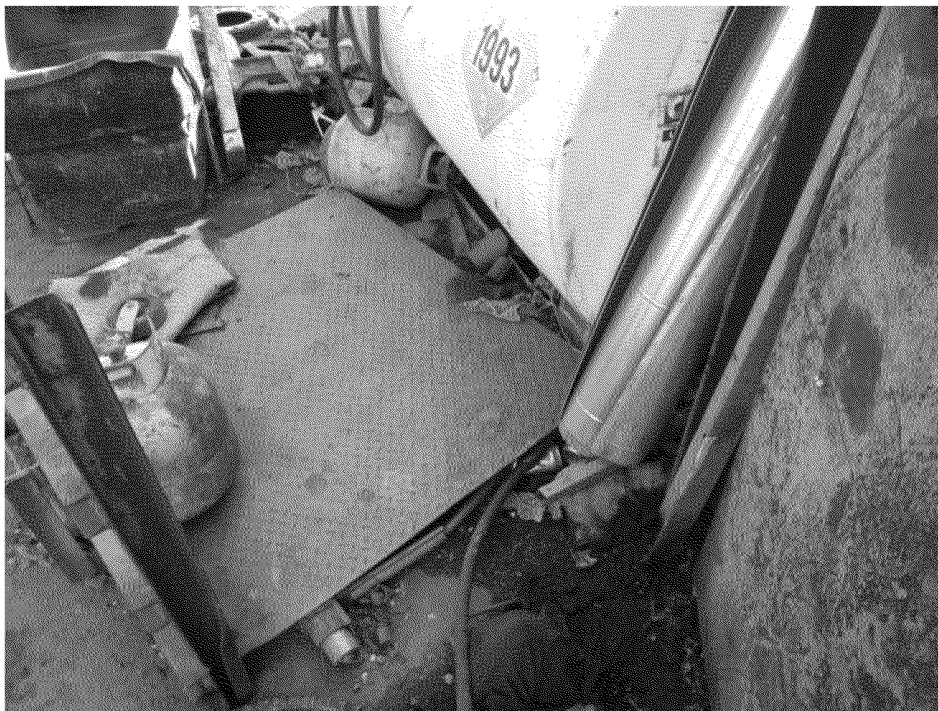
Photograph 57. Scrapped propane tanks stored near 500-gallon fuel tank.

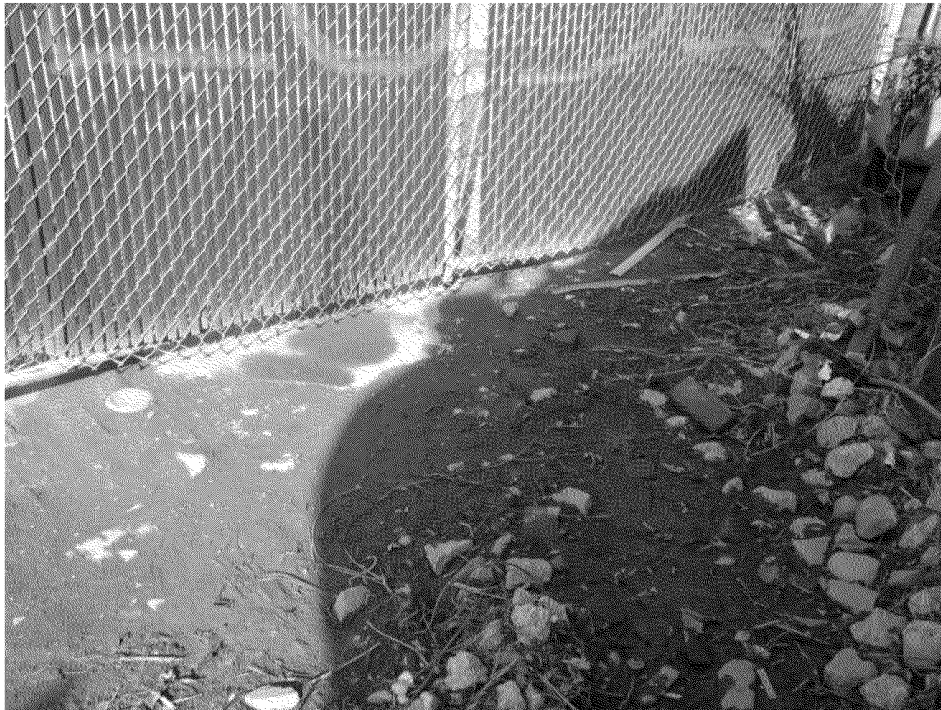
Photograph 60. Alternate view of Entrance 2 to show the staining is not due to shadows.

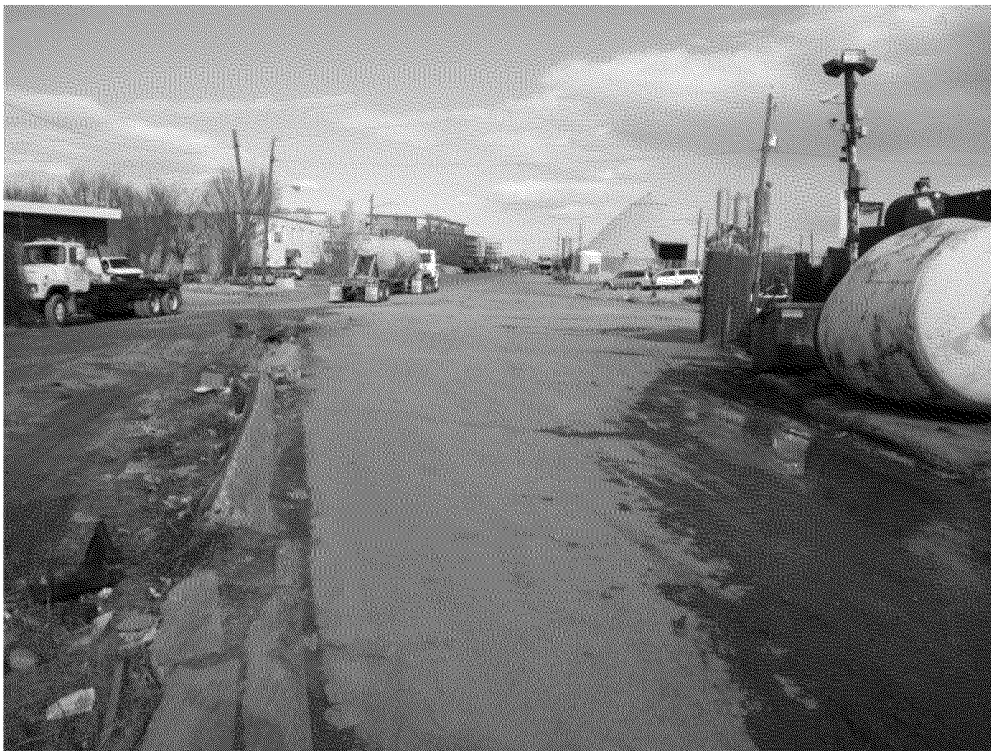
Photograph 62. Alternate view of sediment residue around Entrance 2.

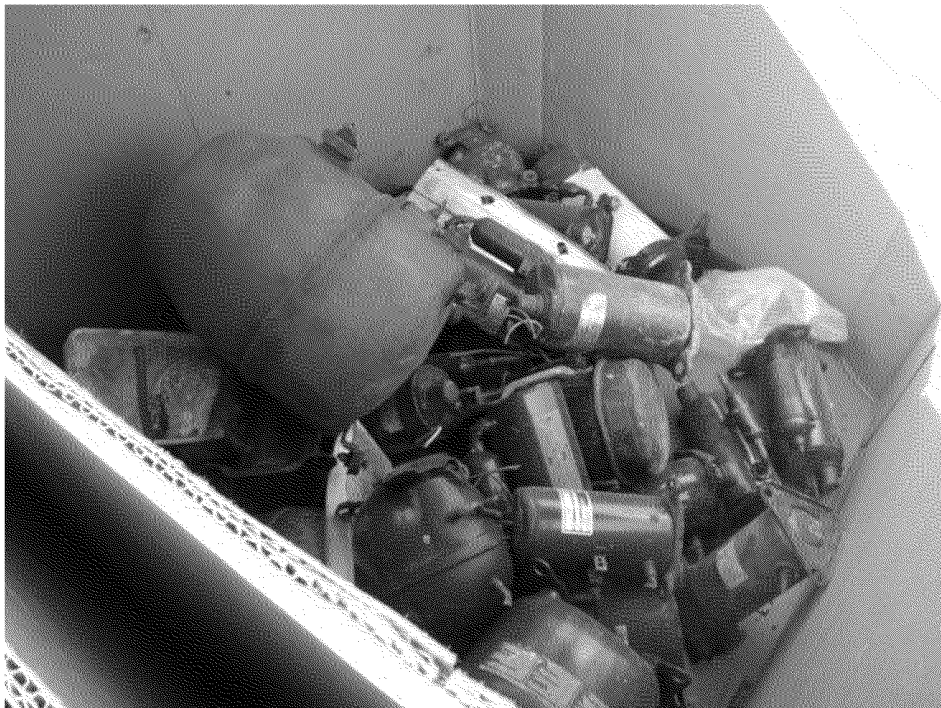
Photograph 66. **View of inside of box with staining shown in Photograph 65. Box contains engine parts.**

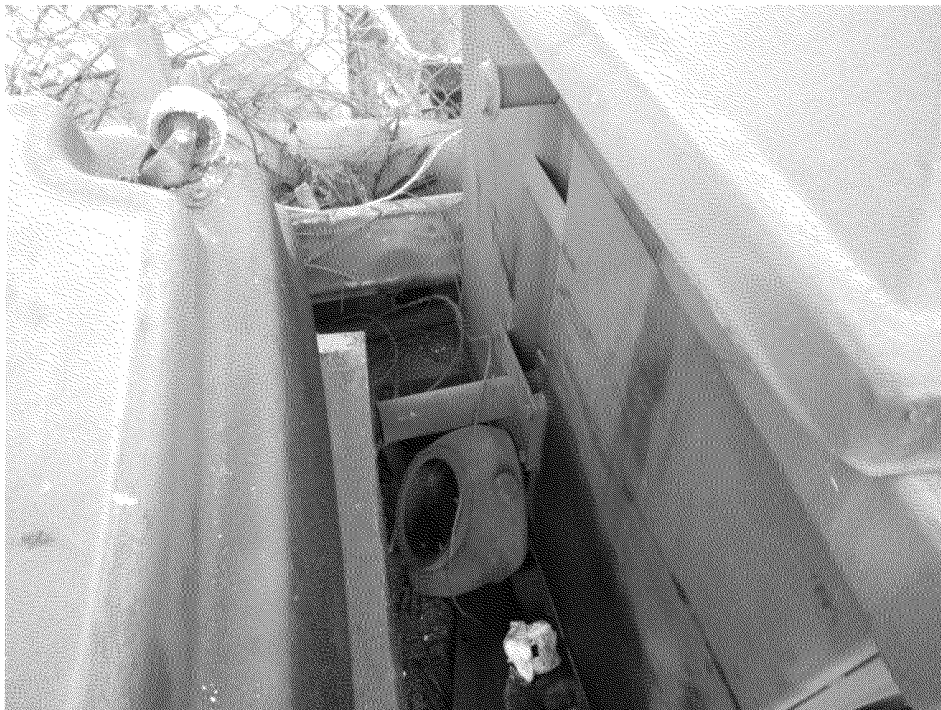
Photograph 72. Alternate view of container from Photograph 71 showing exterior staining.

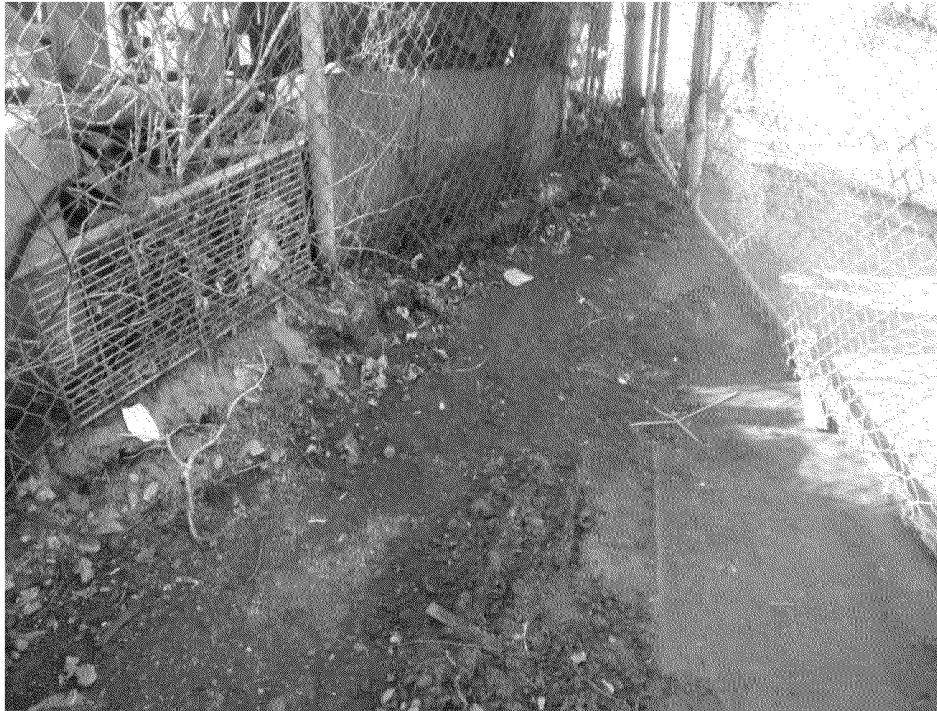
Photograph 73. View from the outside of the perimeter fence showing staining.

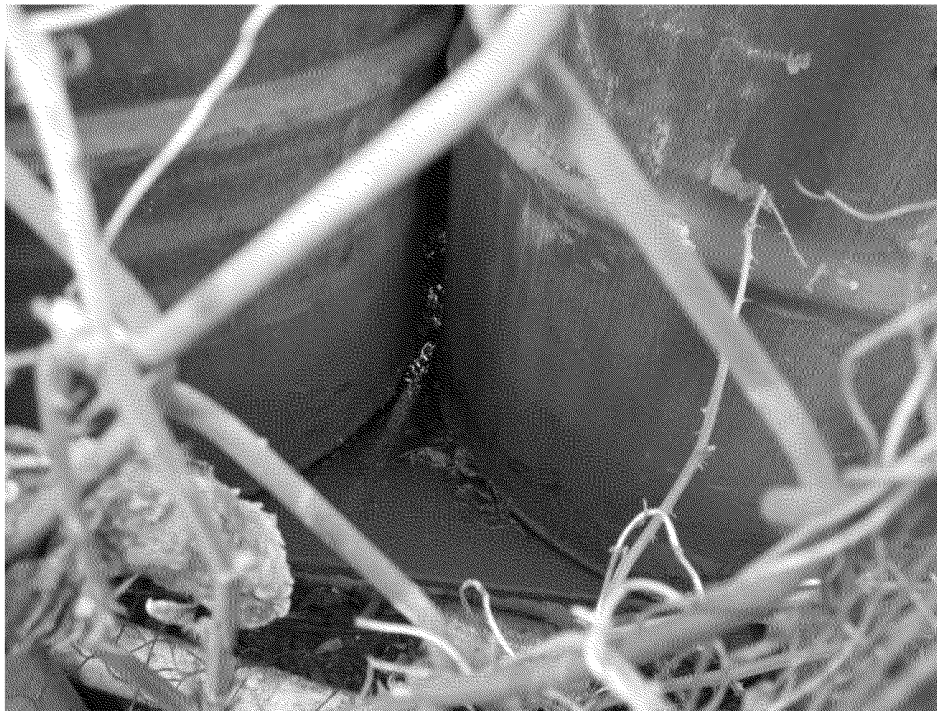
Photograph 74. Close-up view of two barrels containing used oil filters sitting on top of secondary containment . Containment is adjacent to the berm.

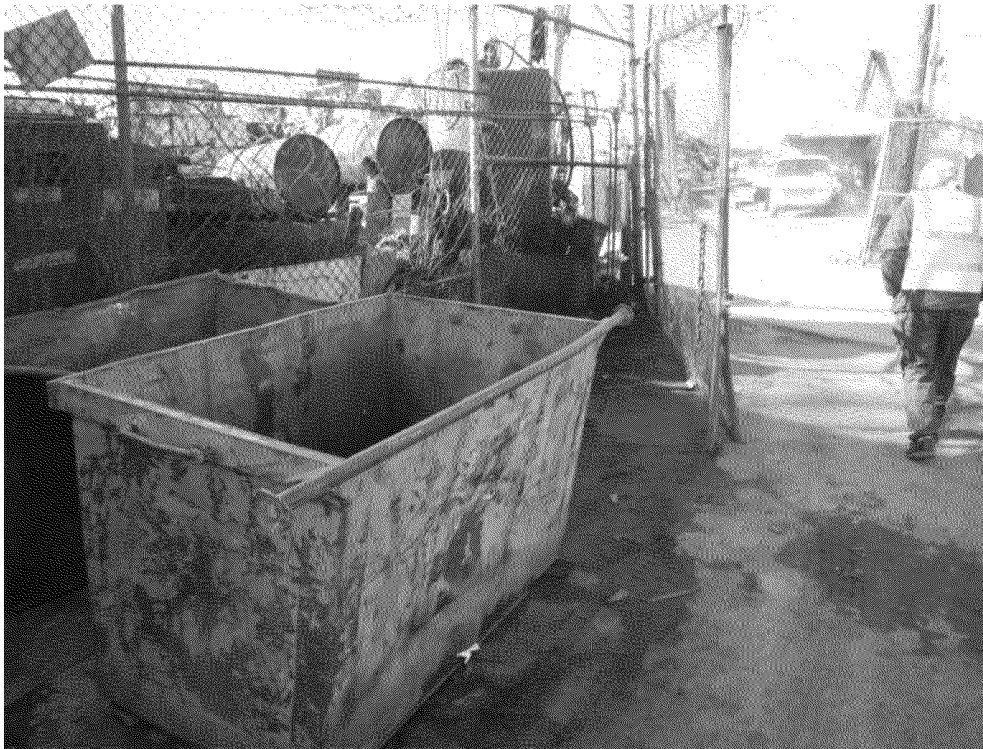
Photograph 78. **Staining and old dumpsters near Entrance 1.**

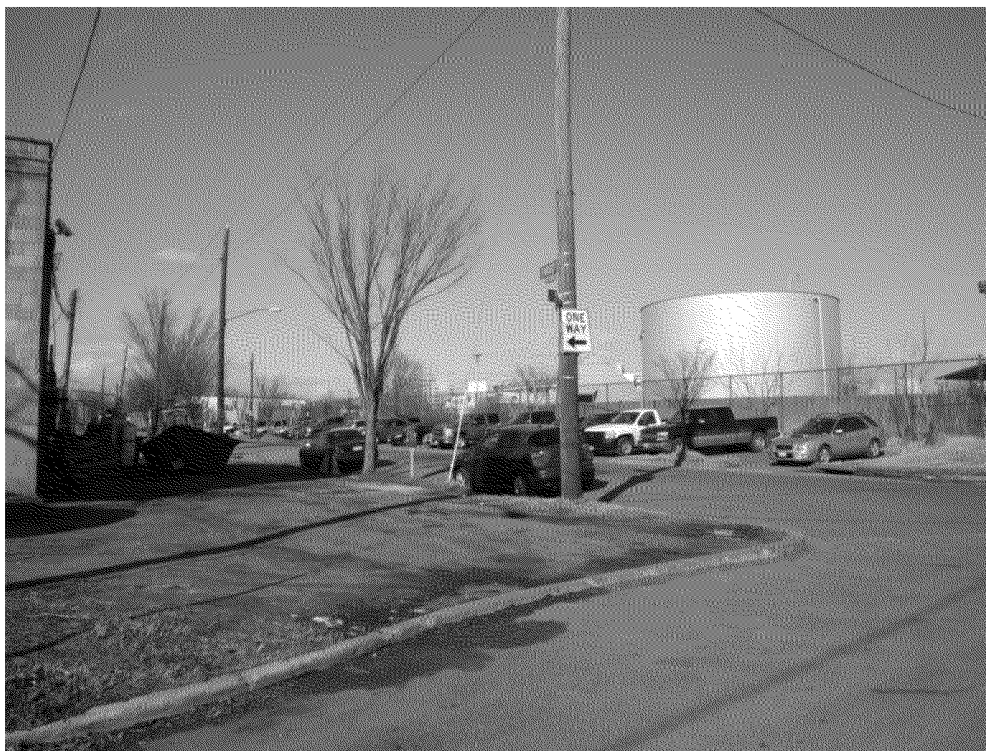
Photograph 82. Staining at the intersection of First Street SW and S Street SW.

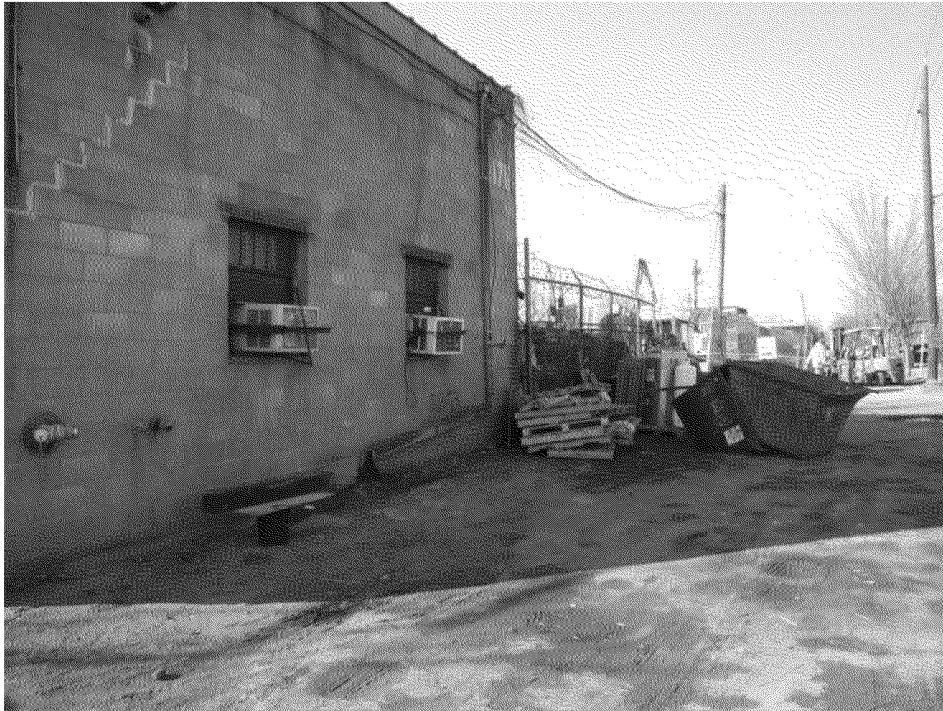
Photograph 83. View of the gutters and roof drains and the stained exterior of the facility near the corner of First Street SW and S Street SW.
